THE IMPACT OF HARSH ENVIRONMENTS AND IONIC CONTAMINATION ON POST-REFLOW CIRCUIT ASSEMBLIES

Michael Konrad
Founder/CEO
Aqueous Technologies
Corona, CA USA
konrad@aqueoustech.com

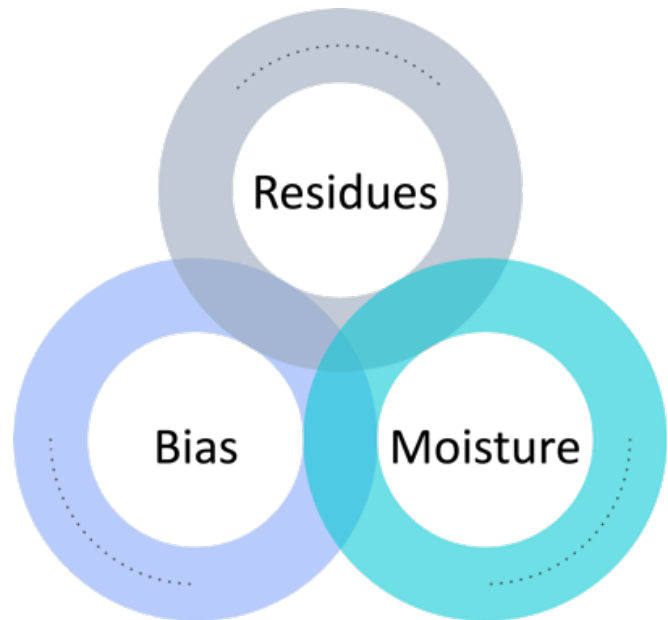
Figure 1: Three causes of ECM

In reality, there are three factors [Figure 1] which, when combined, have the potential to result in electrochemical migration. These three factors are an electrical bias, ionic residues, and moisture.

Electrochemical migration (ECM) is a degradation mechanism that occurs in the presence of moisture, a biasing voltage, and ionic contamination [Figure 2]. It involves the movement of metal ions across a substrate, leading to the formation of conductive metal filaments. This phenomenon is particularly problematic in high-density circuits, where tight

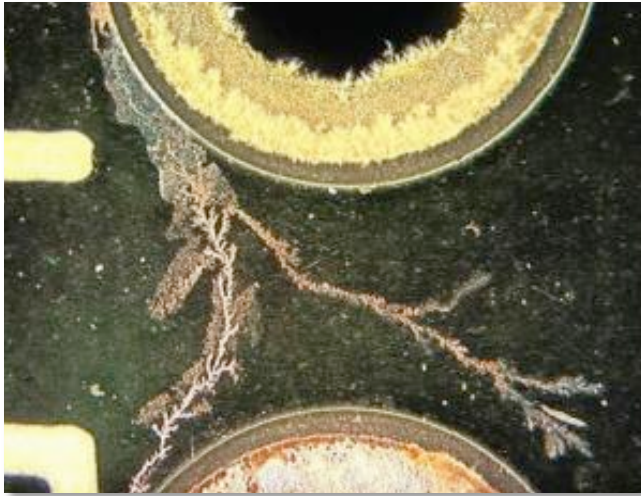
Figure 2
Dendritic growth - Courtesy Process Sciences

At the cathode, the metal ions are reduced back into solid metal, forming dendritic structures, also known as metal filaments. Over time, these dendrites grow and can bridge adjacent conductors, causing short circuits.

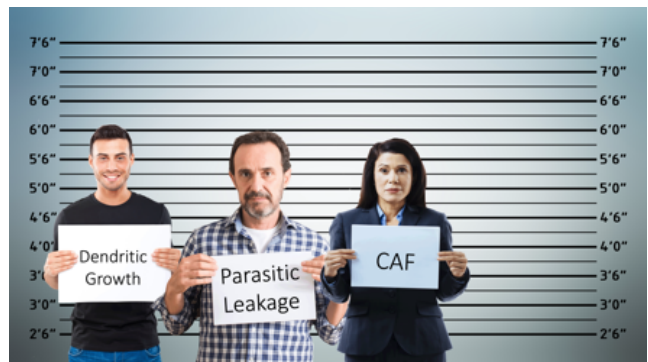
In the early 1990s, many assemblers, in an effort to eliminate a cleaning process, switched to the use of “no clean” fluxes. While this strategy was largely successful for the greater part of two decades, miniaturization along with accompanying high density component placement, reduced the circuit assembly’s tolerance for residue. Adding insult to injury, the elimination of a cleaning process not only allowed no-clean flux residues (albeit minimal), to remain on the assembly, it also allowed all other forms of contamination to remain on the assembly. This includes residues from board and component fabrication, various process residues, and human residues (the “usual

Figure 3: ECM Manifestations

suspects”) [Figure 3]. These residues, in totality, have proven to be problematic on modern circuit assemblies.

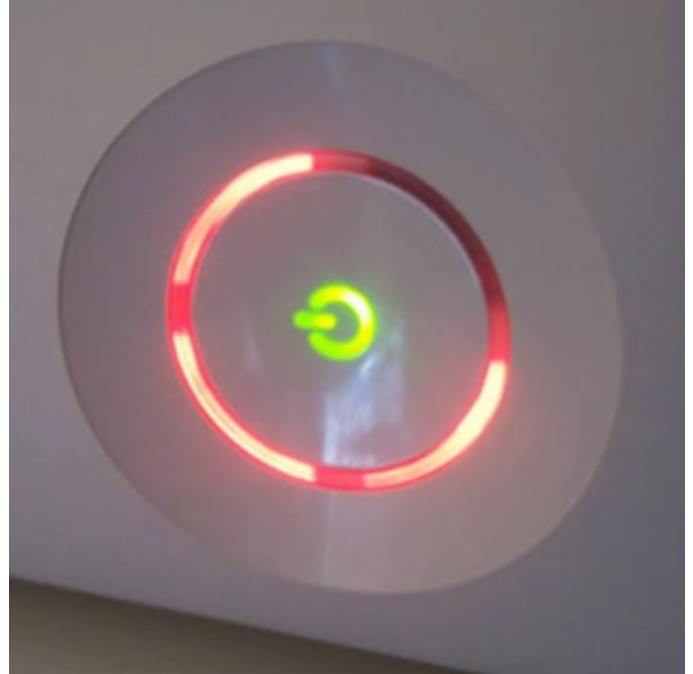
Figure 5: Xbox 360's "Red Ring of Death"

One of the most well-known failures in consumer electronics history is the infamous "Red Ring of Death" (RRoD) that plagued Microsoft's Xbox 360 gaming consoles [Figure 5]. While various factors contributed to the widespread failure, including poor thermal management, electrochemical migration also played a role in some of the failures.

The Xbox 360's motherboard design featured densely packed components, with small traces and vias vulnerable to the effects of ionic contamination. The lead-free solder used in the assemblies was highly susceptible to forming conductive paths when exposed to moisture. Reports indicated that ECM caused dendrite formation between the power and ground planes, leading to short circuits and intermittent failures in some units.

The problem was exacerbated by the console's thermal design, which allowed significant heat buildup during use. As the console cooled down, condensation could form, further promoting the conditions necessary for ECM to occur.
