Non-Destructive Techniques for Identifying Defect in BGA Joints-TDR, 2DX, and Cross-Section-SEM Comparison

By Zhen (Jane) Feng, Ph.D., Juan Carlos Gonzalez, Sea Tang, Murad Kurwa, and Evstatin Krastev, Ph.D.

Abstract

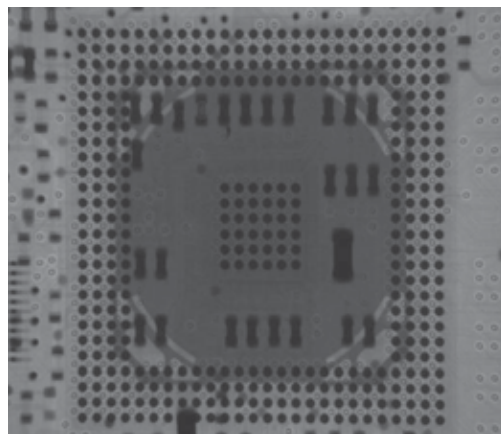
Figure 1 BGA DMN-8802 Dual Encoder Processor

Equipments used for our work were a LeCroy WE100H mainframe with ST-20 TDR module, an Agilent Laminography 5DX, a Dage XD7500 transmissive X-ray, and a JEOL Scanning Electron Microscope. These are TDR, AXI, 2DX and SEM, respectively. The BGA DMN-8802 Dual Encoder processor has defects based on ICT and FT testing, and was selected as the object of our experiments. The BGA is on a board which is Set-Top Box bundled with user-controlled broadcast, frame enhancement and network access. The BGA X-ray image is shown in Figure 1. The fab, which has six layers has 388 pins with pitch size of 0.75 mm. Thirty BGA pins were selected for the experiment including A24 and C26. Solder joint problems have been reported previously for A24 and C26 using SEM and Dye & Pry. The pins are listed in Figure 2.

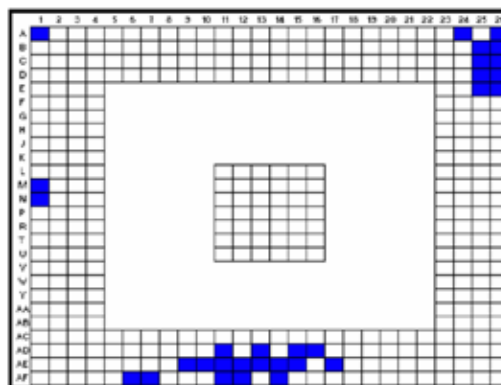
Figure 2 BGA Pins Selected for the Study

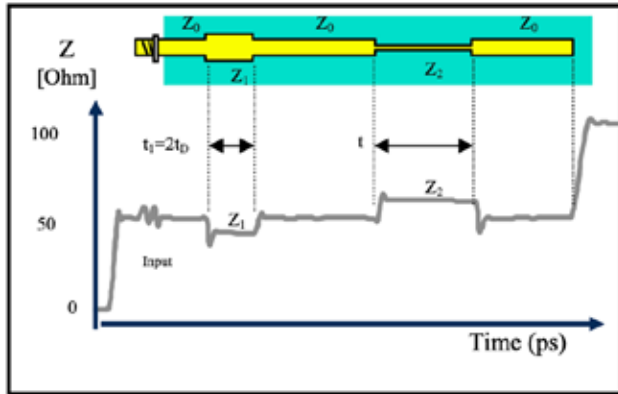
Figure 3 TDR Impedance of a Complex Line (Trace)

The LeCroy ST-20 RMS has 20 GHz Bandwidth, 700 μ V noise, 2.92 mm K-connector, and integrated 18 ps TDR step generator. The resolution is half step rise time (9 ps) which is 1.25 mm on PCB. The resolution means the minimum distance among two impedance mismatch points. If the two impedance mismatch points are so close that the distance between them is smaller than the TDR resolution, TDR will take it as one impedance mismatch point. If the trace is totally broken, even if the gap is lower than 1.25mm, TDR can detect it.

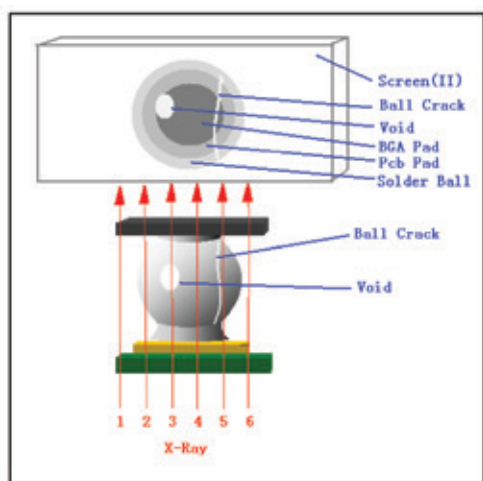
The Dage XD7500VR machine was used for the study after TDR and AXI testing. The X-ray absorbency of a particular material depends on its atomic number and density. Figure 4 shows how the transmission X-ray image is generated from a BGA ball and pads. It is an image showing grey level variations (detector bandwidth is 65,000 grey levels). The darker areas correspond to a higher X-ray absorption that is due to thicker material and/or material that absorbs the X-rays to greater extent. For instance metals absorb X-rays much more than organic material for the same thickness. In Figure 4, ray number 4 is absorbed more than ray number 2. The void and crack are lighter on the images as less X-rays have been absorbed. We might not be able to detect the crack if the difference in absorption between rays is very small. Figure 5 shows two different configurations for the X-ray inspection. Trying to detect cracks from X-ray direction A is very difficult because there is a large amount of material absorbing the X-rays and hiding the crack. Identifying the crack from direction B is much easier and the crack size can be measured. However looking at the board at 90 degrees is impractical as there are many obstacles in the X-ray path. Dage XD7500 has an oblique angle viewing capability of up to 70 degrees. It uses open transmissive X-ray tube technology and has sub-micron (0.950 μ m) feature recognition.

Figure 4 How Transmission X-ray Image Is Generated?

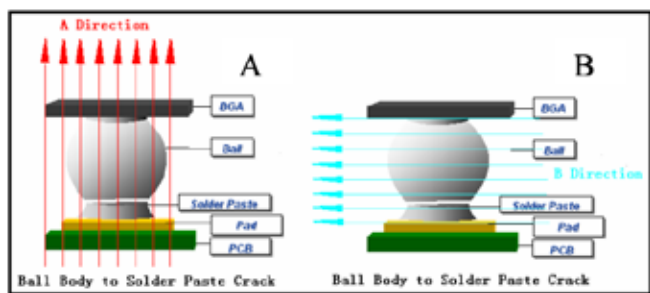
Figure 5 2DX Imaging of BGA Crack

oblique and rotation angles of the X-ray detector are key factors for identifying small cracks⁵. The images were collected for all 30 pins of the 10 boards, and measurements were done for some joints with cracks. It is noted that 2DX measurement data for cracks (below 4 mils) is just for reference as the most accurate measurement is accomplished using top view.

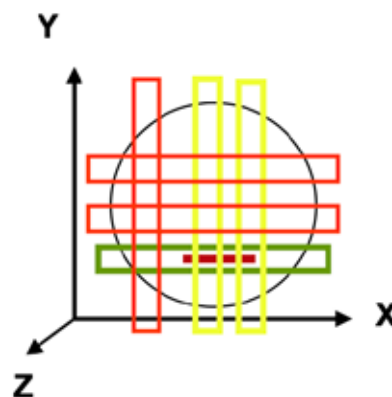
After completing TDR, AXI and 2DX, eight boards were sent for Cross-section/SEM. We chose the best fitting mounting cup, uniformly applied resin, and grinded very carefully at the location of interest which was previously precisely aligned. The cross section has the following limitation that is explained in Figure 6. The solid red line is a micro-crack in the X-Y plane. The rectangular boxes (red, yellow and green colors) are Cross-section locations. We will not detect the crack if the cuts are made in the red locations. The crack will appear as a dot on the SEM image if the cuts are made in the yellow locations. The green color box indicates the “PERFECT” cross section location. However no one knows in advance where this “perfect” cross section location is. Therefore the grinding needs to be done

Figure 6 Limitation of Cross-section/SEM Technique (The BGA pad is on the X-Y plane)

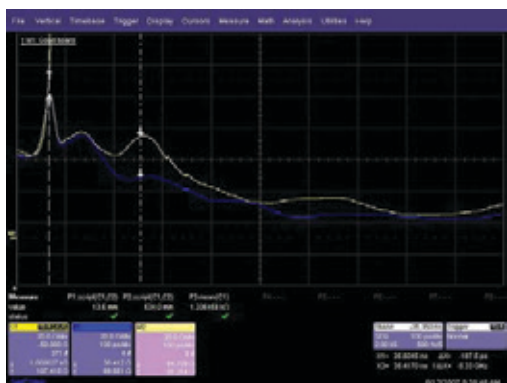
Figure 7 is TDR measurement graph for pin A1 of board (S/N 17385), where M1 is the reference data from a golden board, the impedance is 38.4 Ω ; the impedance for M2 is

64.7 Ω , which is the test pin A1. Based on the TDR data, it is easy to tell the pin has an open defect. The pin A1 is missing ball, all TDR, AXI, 2DX and SEM called it as defect. Figure 8 shows pin A26 on the same board (M1 = 41.2 Ω , and M2 = 59.2 Ω). It shows open defect as well. This pin was found defective by 2DX and SEM also. Figure 9 is the TDR graph for pin C26 on the same board (M1 = 60.7 Ω , M2 = 60.6 Ω). The difference between them is about 0.1 Ω . So it is not identified as defective ball by TDR. Actually the BGA ball has about 1.5 mil cracks. Table 1 lists the results for this board: column 1 is the pin # location; column 2 is the length of the trace between the test point and the solder ball of the BGA; the impedance columns have TDR measurement data for reference

Figure 7 TDR Shows Open Defect (pin A1 board 17385)

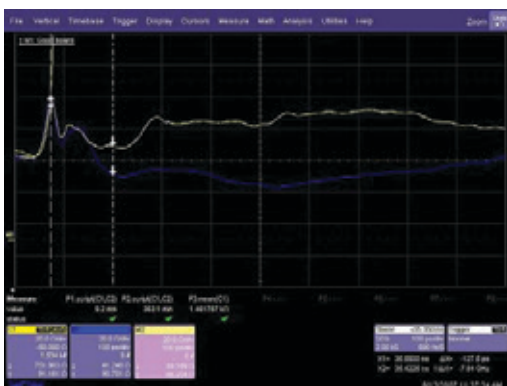
Figure 8 TDR Shows Open Defect (pin A26 board 17385)

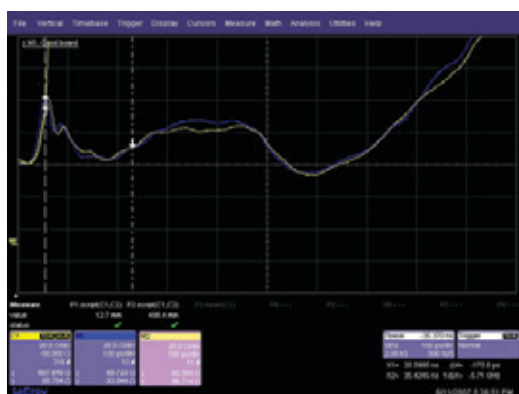
Figure 9 TDR Shows Good Joint (pin C26 board 17385)

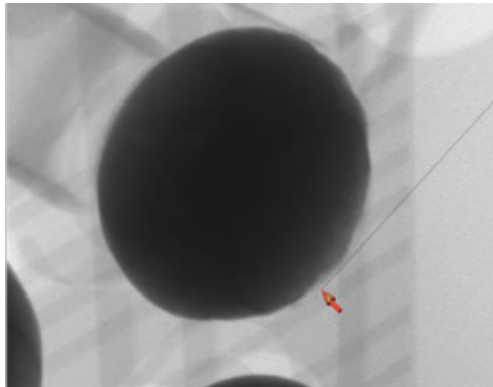
Figure 10 is a 2DX image of pin A26 on board 17385 where a 40 μm crack is found at the BGA side; the defect is found by TDR and SEM as well. Figure 11 is for pin C26 and shows correlation with SEM data showing a crack of about 30 μm on the BGA chip side. Figure 12-13 are for pins A26 and B25 on board 13907. 2DX has correlation with TDR and SEM at pin A26 where both BGA chip and PCB sides are defective (crack size is 40-140μm). But only 2DX and SEM found a defect at B25 — crack at FR4 side of the BGA ball.

Figure 10 2DX Image (pin A26, board 17385)

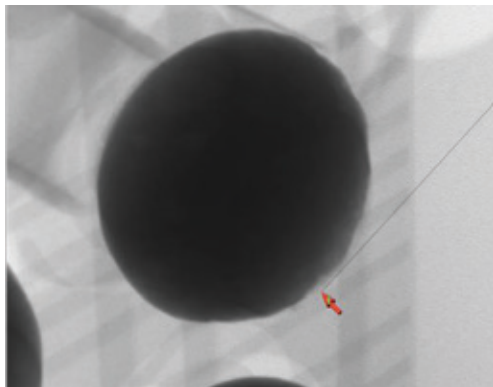
Figure 11 2DX Image (pin C26, board 17385)

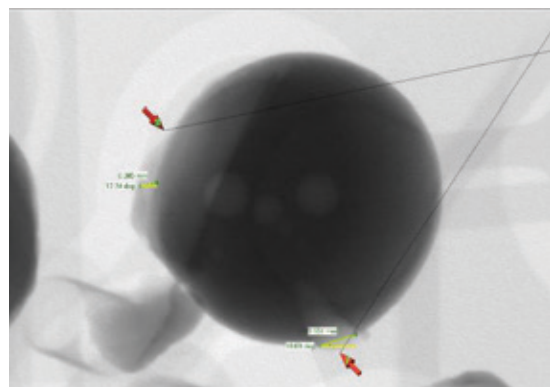
Figure 12 2DX Image (pin A26, board 13907)

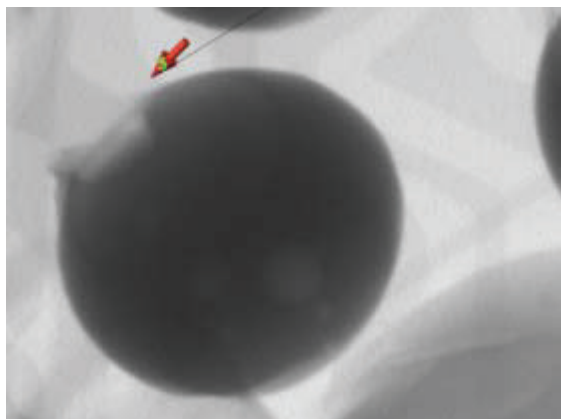
Figure 13 2DX Image (pin B25, board 13907)

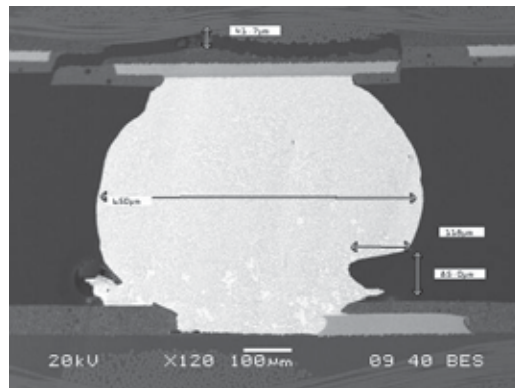
Figure 15 SEM Image (pin B25, board 13907)

We have 240 Cross-section/SEM data points. Figures 14 -15 are SEM images for pin A1 and B25 of board 17385 and 13907 respectively. Both 2DX and SEM found a defect for those two locations. Figures 16A and 16B are SEM images at the different locations for pin A26 on board 13907. Ball diameter is 788µm at Figure 16A and 826µm at Figure 16B. There are about 38µm difference for ball diameter between these two cross sections, and about 44µm difference for the void diameter between the SEM images. Both images show clear cracking at the BGA chip level, and only Figure 16B shows defect at the ball edge. SEM indicates 72 pins total with defects and 41 pins have correlation with 2DX. The detail of SEM and 2DX results is listed in Table 3, and 51.3% data points have defect agreement between SEM and 2DX.

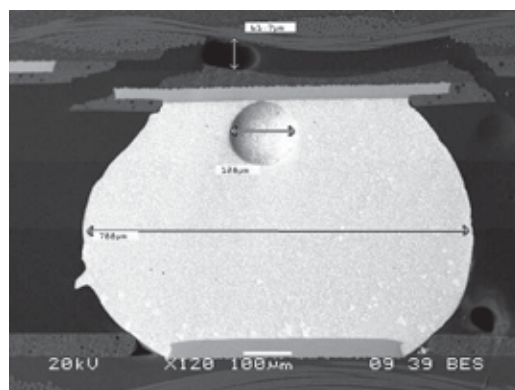
Figure 16A SEM Image (pin A26, board 13907)

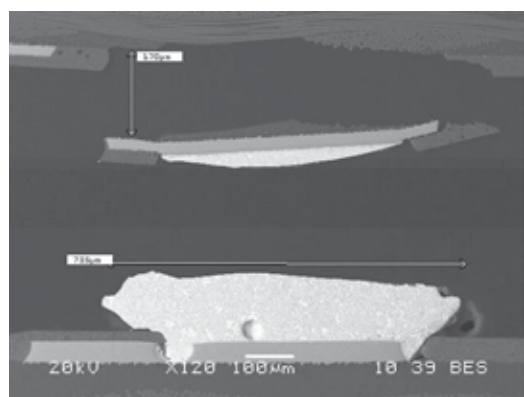
Figure 14 SEM Image (pin A1, board 17385)

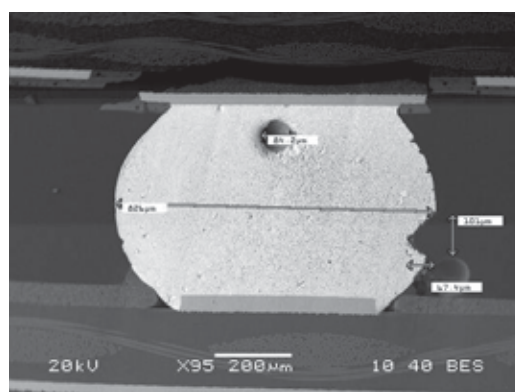
Figure 16B SEM Image (pin A26, board 13907)

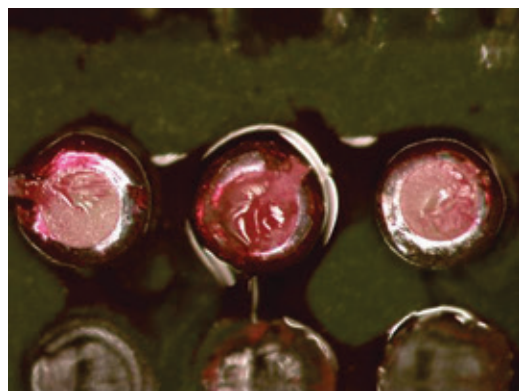
We used two boards for Dye & Pry study, in which 60 data points were collected. Figures 17A (BGA side) and 17B (PCB side) show Dye & Pry images for pin A26 on board 17159 revealing defect. Twenty pins were identified as defective and are listed in Table 3. Fourteen of 20 (70%) Dye & Pry data shows good correlation with 2DX.

Figure 17A Dye & Pry Image BGA Side (pin A26, board 17159)

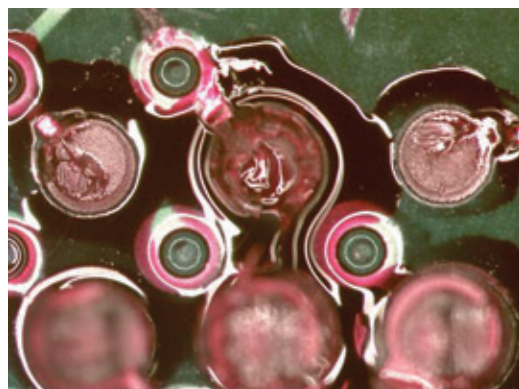
Figure 17B Dye & Pry Image PCB Side (pin A26, board 17159)

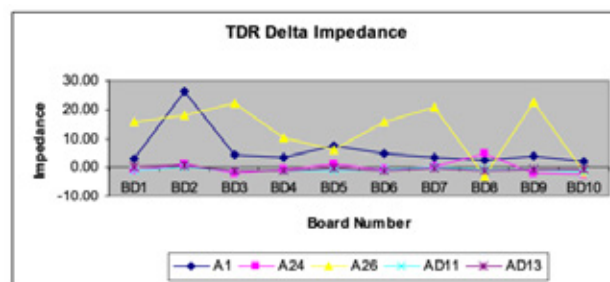
The impedance of TDR for the first 5 pins of 10 boards is shown in Figure 18. If the impedance is bigger than 7 ohm, the pin is very likely defective. Figure 19 shows delta impedance of TDR for 300 data points. $\Delta\Omega$ between $-7\ \Omega$ to $+7\ \Omega$ indicates mostly good solder joints. The largest delta impedance is $45\ \Omega$ due to a defect located on the BGA ball side. All TDR, 2DX, and SEM identified the ball as defective (Figures 20-22).

Figure 18 Delta Impedance of TDR for Five Pins of Ten Boards

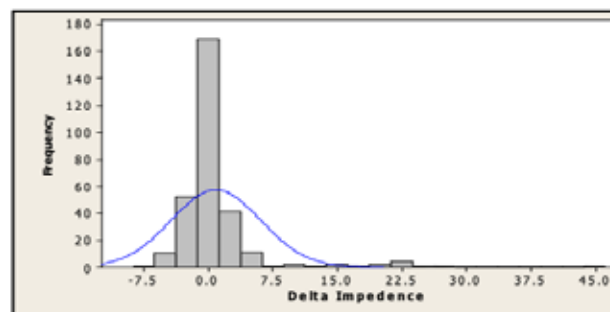
Figure 19 Delta Impedance of TDR for 300 Data Points

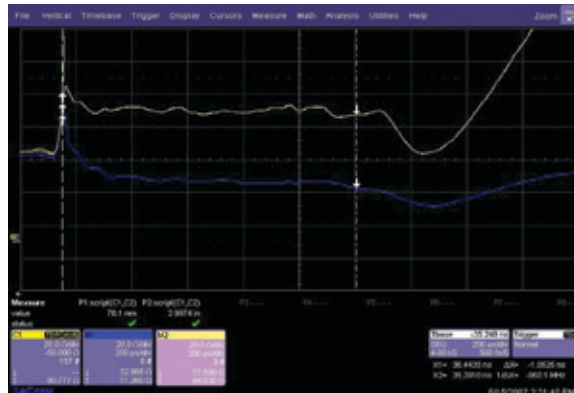
Figure 20 TDR Image (pin AF11, board 16596)

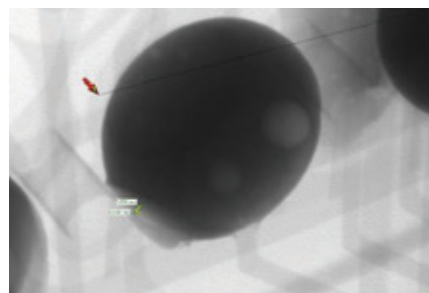
Figure 21 2DX Image (pin AF11, board 16596)

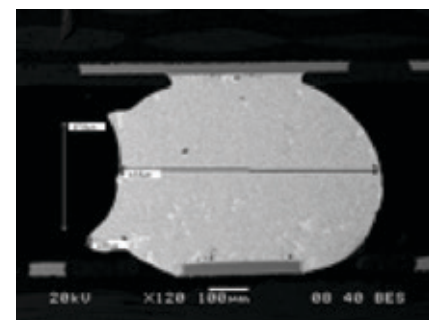
Figure 22 SEM Image (pin AF11, board 16596)

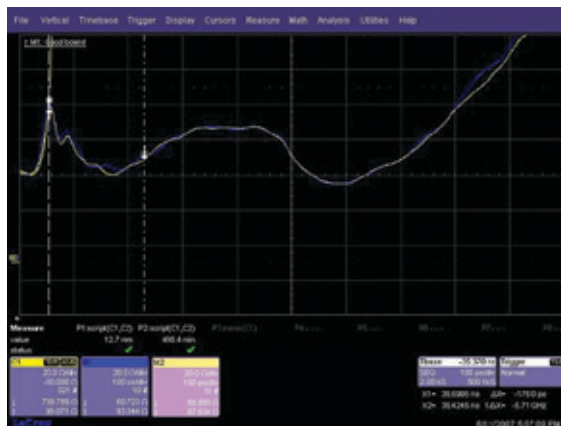
TDR found less defective balls than 2DX and SEM because of its resolution. The current TDR has limitation finding small crack defects (Figures 23) due to its resolution. 2DX and SEM show obvious defect (Figure 24 -25) on the same ball.

Figure 23 TDR Image (pin C26, board 11201)

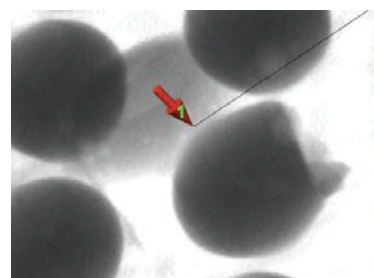
Figure 24 2DX Image (pin C26, board 11201)

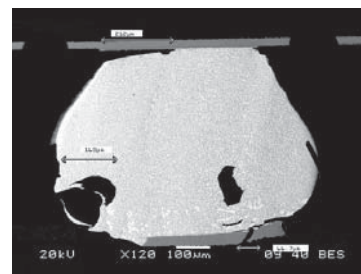
Figure 25 SEM Image (pin C26, board 11201)
